Pro Inspections

Page 1 of 13
7018-1

Client Name: John and Linda Williams
Property Address 1835 Main Street
City Upland State CA Zip 91784

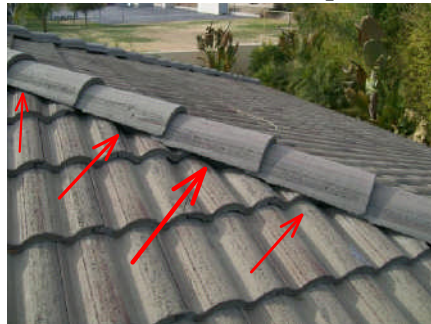
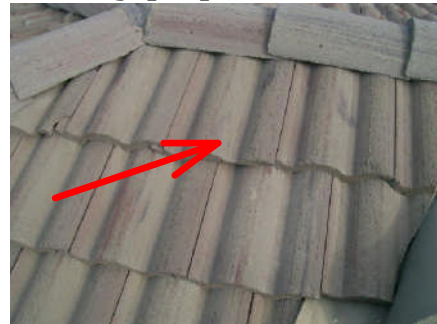
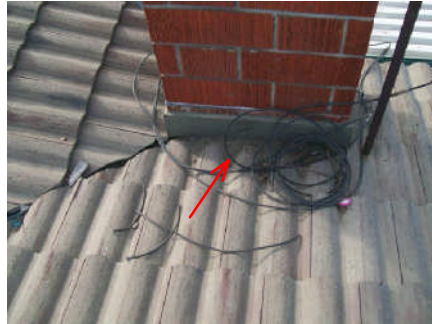
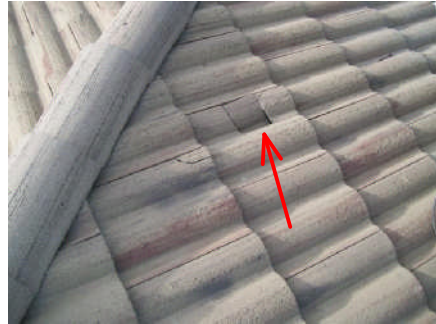
Material: Cement tile- A number of cracked tiles were noted, Missing weather blocking under ridge, Tiles are pushed up to close to chimney not allowing proper water flow

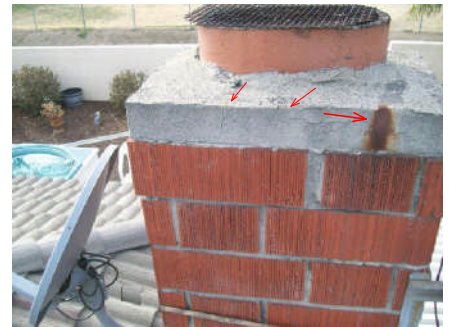
Chimney: Brick
Flue/Flue Cap: Cracks and exposed rebar noted in cement cap

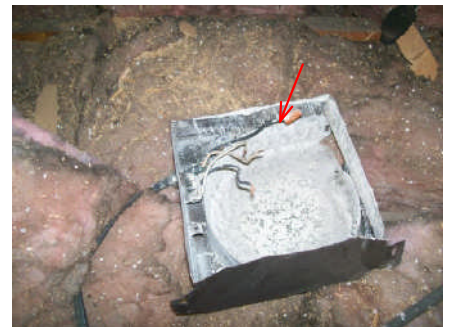
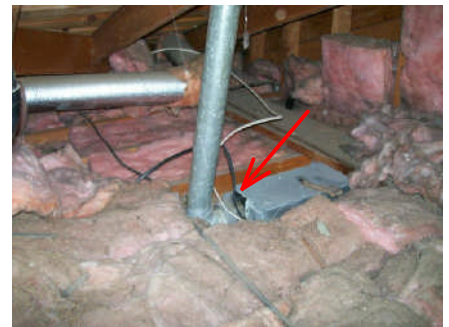
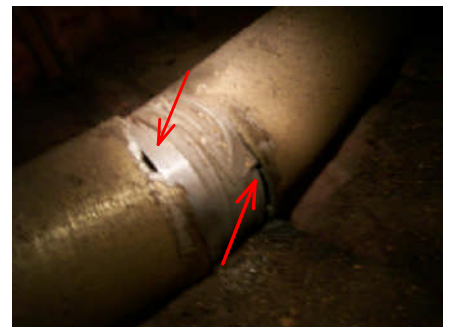
1. Attic Access: Hallway
 2. Method of Inspection: In the attic
 3. Unable To Inspect: 25%
 4. Reviewed
 5. Reviewed
 6. Reviewed
 7. Reviewed
 8. Reviewed
 9. Defective
 10. Safety
 11. Defective
 12. Defective
- Access/Area:**
Roof Framing: 2x6 Rafter
Sheathing: Plywood, Plywood
Ventilation: Roof and soffit vents
Insulation: Batts
Insulation Depth: 0-6 inches Some insulation has been moved and should be replaced.
Wiring/Lighting: Open junction boxes, "Romex" wiring not attached to structure and before junction box
- Bathroom Fan Venting:** Bathroom improperly vents into attic and may cause moisture damage to the insulation
- Exposed Ductwork:** Disconnected ducting noted allowing air flow into attic
