Pro Inspections
11031 Appomattox Court
Rancho Cucamonga, CA 91737

3707 Grey S. Fox Lane
Ontario, CA 91761

Client Name: Mr and Mrs Homeowner
Property Address 1234 Main Street
City Rancho Cucamonga State CA Zip 91701

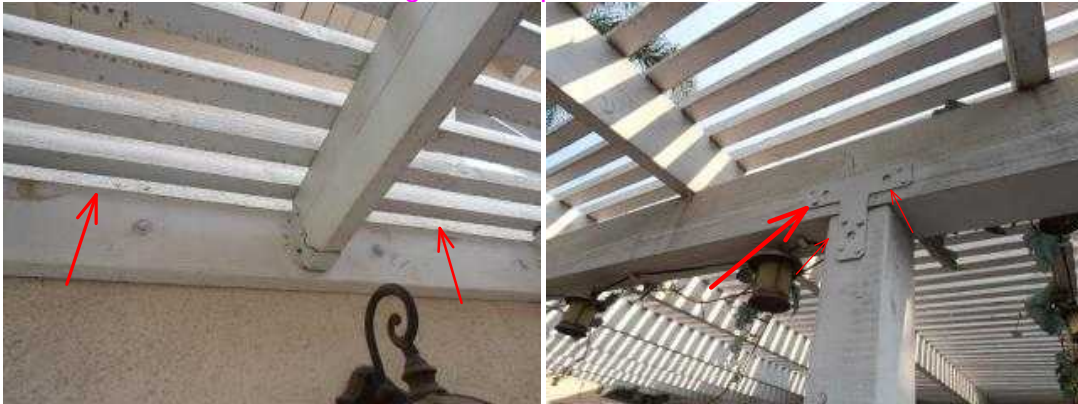
- Maintenance Front Walks: Brick, Concrete- Cracks noted, determining cause could be from settlement or soil movement to improper mixture or placement of concrete
- Safety Back Walks: Brick, Concrete- Lifted concrete poses a trip hazard, Cracks noted, determining cause could be from settlement or soil movement to improper mixture or placement of concrete
- Maintenance Driveway: Brick, Concrete- Cracks noted, determining cause could be from settlement or soil movement to improper mixture or placement of concrete
- Maintenance Patio: Concrete- Cracks noted, determining cause could be from settlement or soil movement to improper mixture or placement of concrete
- Defective Patio Cover: Ledger board is attached to stucco wall without flashing allowing possible water intrusion into bolt holes, Missing bolts on post brackets,

- Defective Grading: Flat to negative grading noted within 6 feet of foundation, Soil and/or concrete within 4 inches of finished floor height, Possible water intrusion
- Reviewed Gates:
- Defective Fences: Loose post, fence wobbles, loose boards.
- Reviewed Sprinkler Valves:
- Defective Planters: Missing weep holes noted at bottom of wall to allow water drainage, Cracks noted
- Reviewed Electrical Yard Outlets:

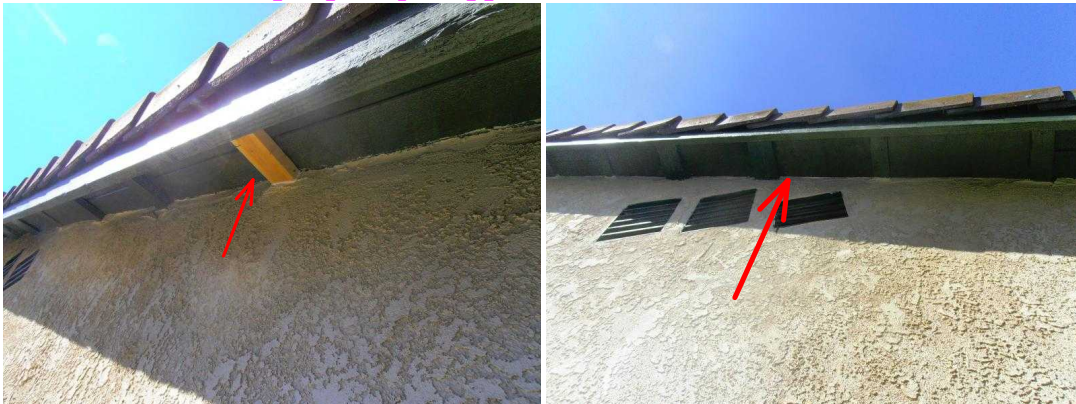
Defective Trim: Wood- Caulking needed at corners or ends of boards to prevent water intrusion.

Defective Fascia: Wood- Not properly supported

Defective Soffits: Wood- Eave extension not attached through attic, Plywood patching noted- possible damaged wood underneath- see termite report

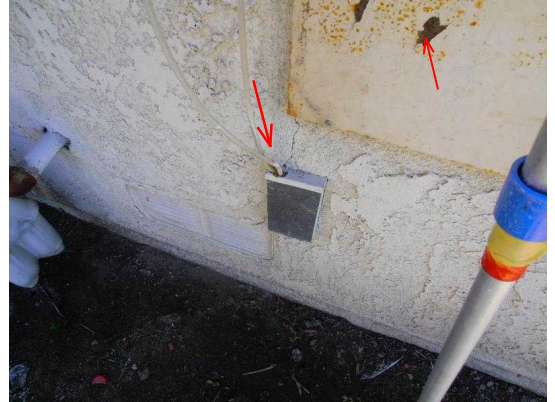
Defective Miscellaneous Exterior: A number of devices noted attached to structure were not sealed to prevent water intrusion, this includes but not limited to light fixtures, AC disconnect box and fence post, Missing drip loop and chalking where TV cable enters wall, Rusted box cover noted

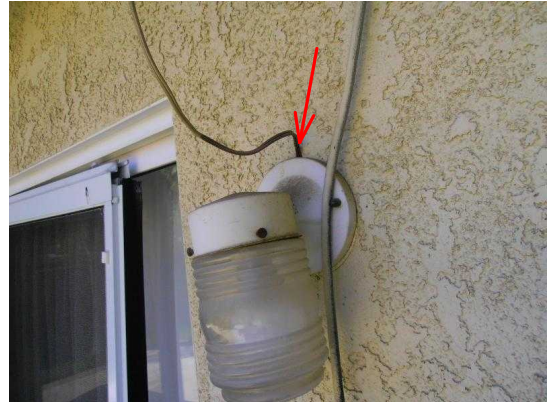
Reviewed Door Bell:
Reviewed Windows:
Reviewed Window Screens:
Reviewed Exterior Lighting:
Safety Exterior Electric: Extension cords used for permanent wiring, Wire pinched under light fixture

Reviewed GFCI Protection: Resets in master bathroom-
Safety Hose Bibs: Missing vacuum breakers on hose faucets.

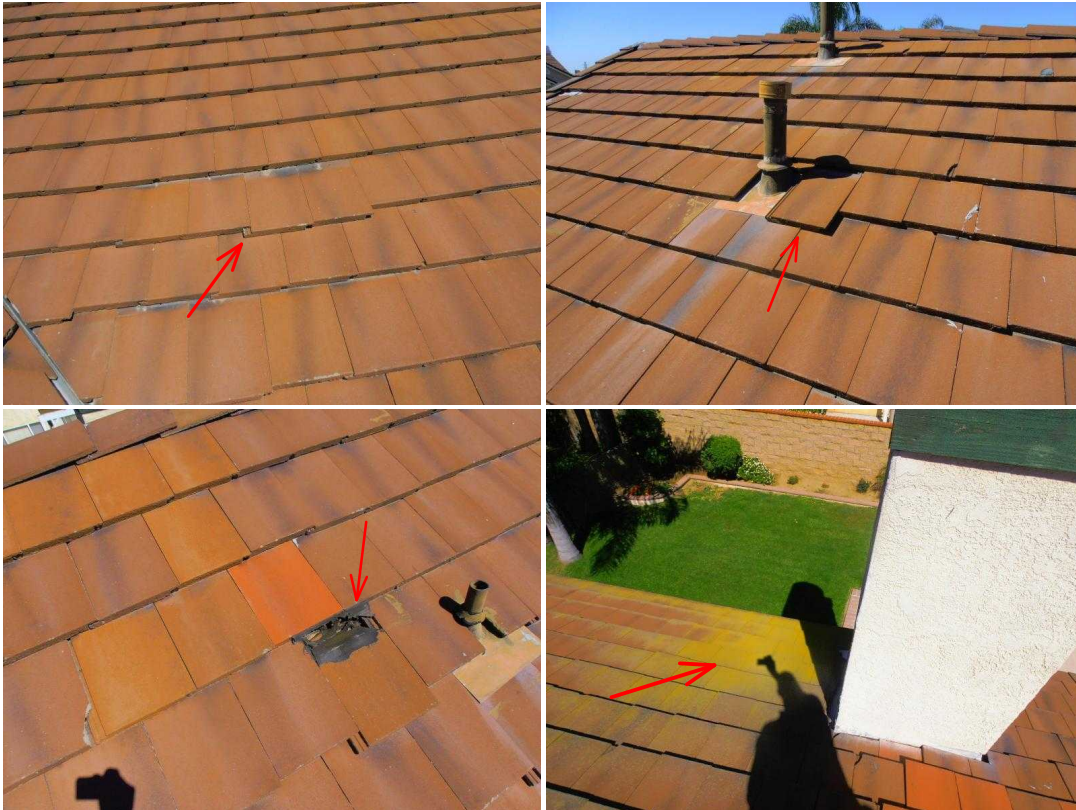
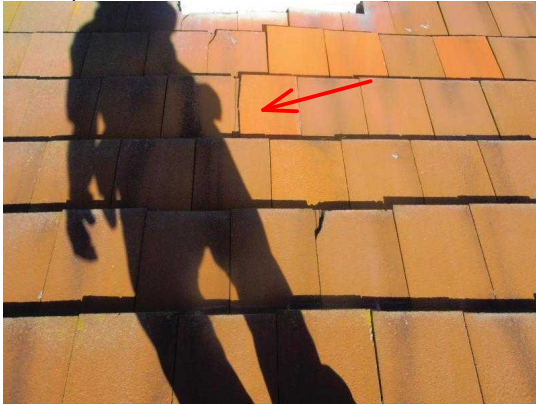
Defective Material: Concrete tile- A number of cracked, loose, or missing tiles were noted allowing possible water intrusion, Exposed and damaged tar paper noted, Missing wind clips on first row to prevent lifting, Missing fasteners (nails) noted, Patching noted, Tile replacement noted with missed matched tiles, Algae growth noted on tiles

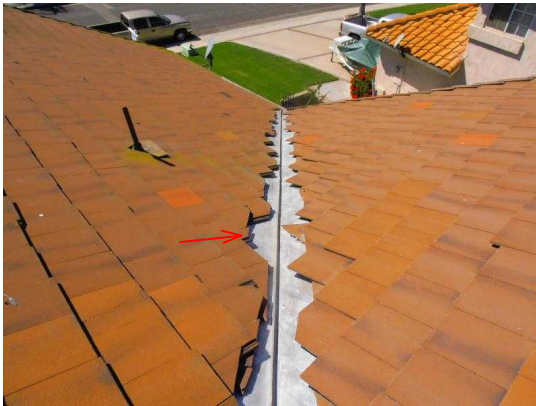
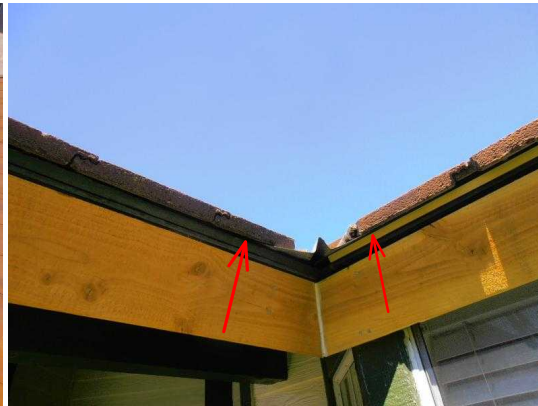
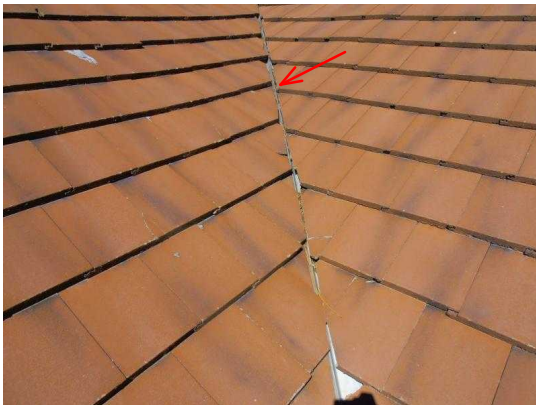
Defective Valleys: Valley tiles too wide and not properly installed on north valley, Valley flashing doesn't extend past fascia, Valley tiles are pushed too close together restricting good water flow from roof, Valleys are full of debris and should be cleaned to allow better water flow from roof

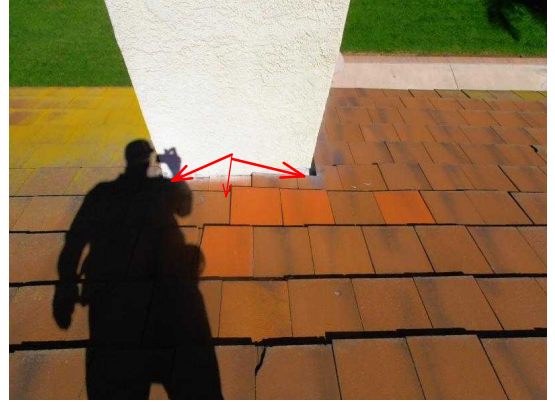
- Reviewed Flue/Flue Cap: Unable to view the interior of flue, Unable to determine if shroud is approved for fireplace
- Reviewed Spark Arrestor:
- Defective Chimney Flashing: Chimney lacks cricket flashing to direct water away

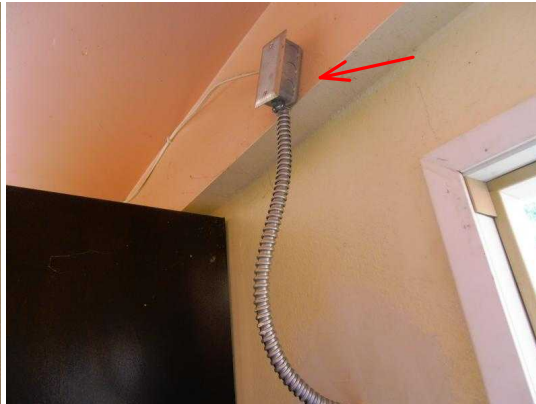
Safety Electrical: Exposed unprotected wiring noted below 8 feet, Wiring not properly installed into junction box, Loose junction box noted, Missing plate covers over receptacles and/or switches

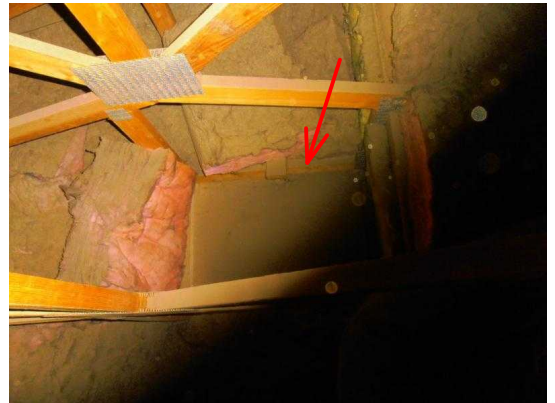
Defective Insulation Depth: 0-8 inches- **Missing insulation in various location**

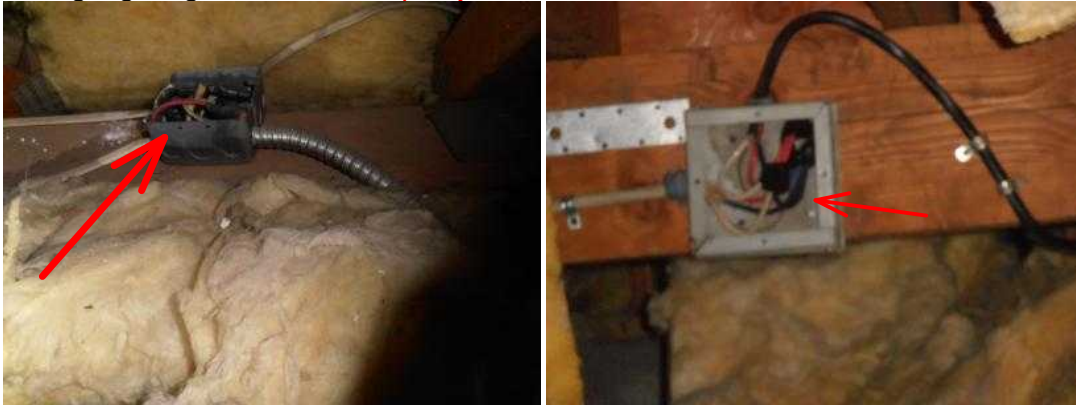
Safety Wiring/Lighting: **A number of open junction boxes noted**

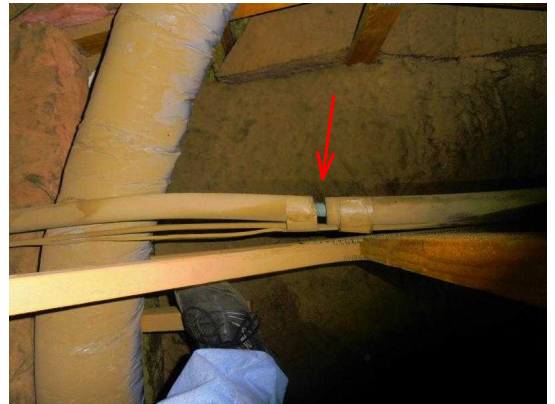
Defective Refrigerant Lines: **Missing insulation in attic, this can cause water damage.**

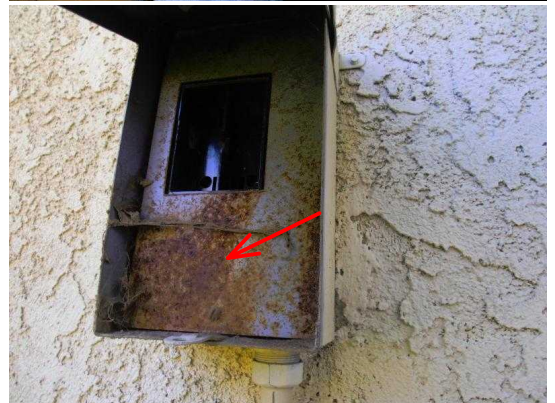
Maintenance Electrical Disconnect: **Rusted box**

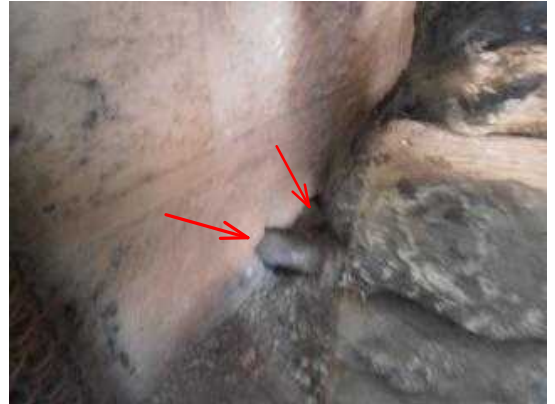
Safety Smoke Chamber: **Cracks noted in side refractory panel**

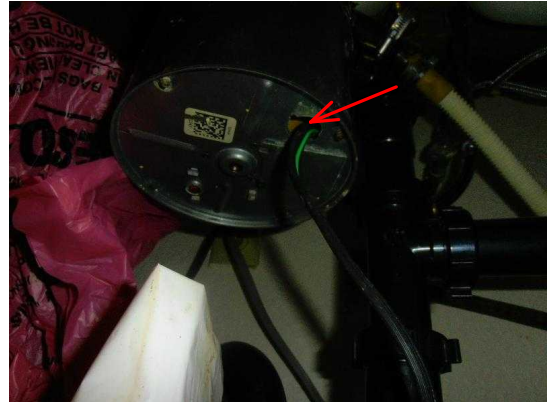
Reviewed Safety Ventilator:
Disposal: **Missing wire clamp, wire clamp prevent electrical wire from pulling out**
